**Ka 8 and Ka 8 B/C**  
**"Rhönsegler"**

**Operating Instructions**

Operating Instructions  
for the Sailplane  
Schleicher K8 and K8 B

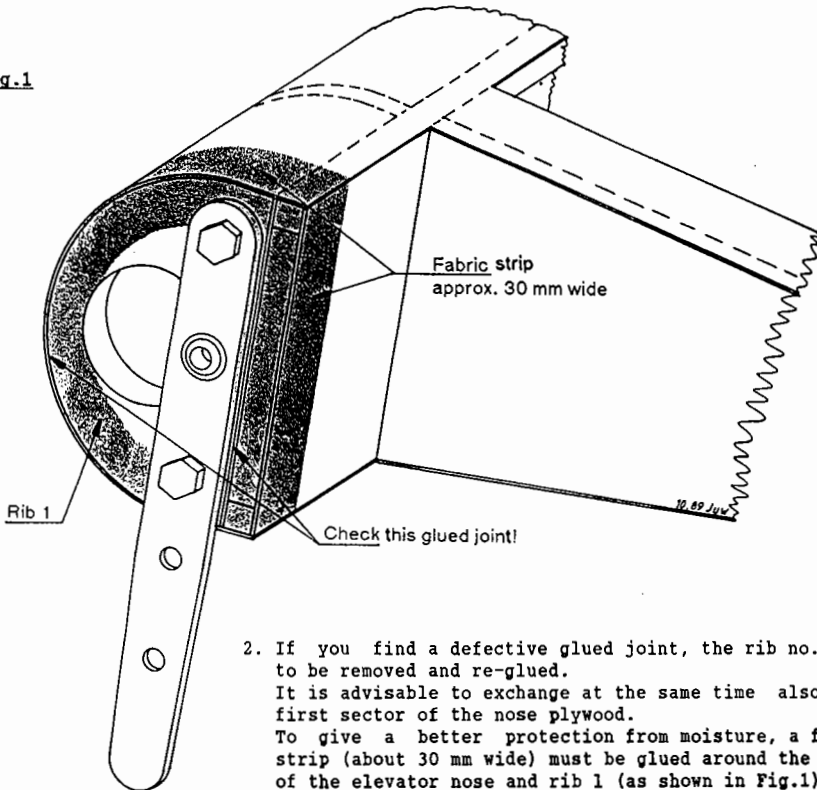
Fig.1

A glider of the model K7 failed to gain normal flight attitude immediately after tow rope release on winch launch. With the stick full back only the left elevator could be actuated in the correct direction; the right elevator deflected downwards. The reason for this was a loose glue bond at the elevator rib 1 at which the elevator fitting is attached. Similar incidents lead already before to the issue of the LTA 72-7 dated Feb.9,1972.

Loose glue joints on rip 1 of the elevator

1. Remove elevator.  
Check that the glued joint between rib 1 and the leading edge plywood and the elevator spar respectively is in good condition (see Fig.1). Before doing so check whether the LTA 72-7 of Feb.9, 1972 was already previously accomplished (this is not applicable to K9, K11 and ASK 18); if yes then the fabric strip first carefully has to be detached in order to be able to check the glued joint.

2. If you find a defective glued joint, the rib no.1 has to be removed and re-glued.  
It is advisable to exchange at the same time also the first sector of the nose plywood.  
To give a better protection from moisture, a fabric strip (about 30 mm wide) must be glued around the edge of the elevator nose and rib 1 (as shown in Fig.1).
3. The above action under points 1. and 2. must be repeated every three years during the annual re-inspection. This copy of the Technical Note must be inserted in the Flight and Operations Manual of the respective glider as an annex and a corresponding entry must be made into the "Amendments to the Manual".

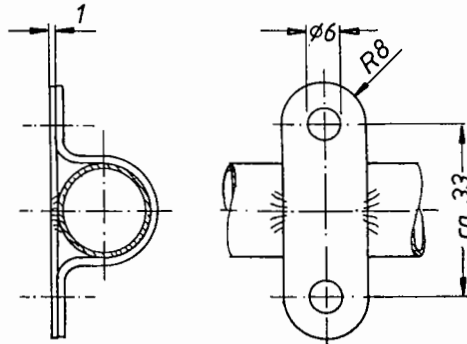
Fig. A2

Reinforcing the attachment collars for pedal boards at the pedal assembly. Material: 1.7734.4  
Welding procedure WIG to spec DIN 1912, welding wire material: 1.7734.2

- ad A2) Checking the rudder pedals:  
With the rudder neutral the pedals left and right must be evenly adjusted. Check the pedal board angle versus the pedal (dimensions see drawing L-216.42-U01). The angle must meet the specified dimension.  
Engage the pedal adjustment into its foremost position and check full deflection of the rudder.  
Where pedals or attachment collars are bent, these can be either repaired or replaced by new ones.  
In order to impede the bending of the pedal boards it is optionally recommended to weld an additional butt strap onto the attachment collar (see Fig.A2).

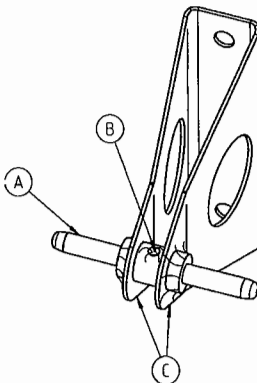
Fig. 1

**Grund:** Bei einem Segelflugzeug wurde festgestellt, daß die Achse (A) des Höhenruderlagers lo-  
**Reason:** *se war. (siehe Fig. 1)*

Die Achse ist in einer Buchse geführt. Durch ein Loch (B) in dieser Buchse ist sie festgeschweißt. Diese Verbindung hat nicht mehr bestanden.

*On one glider it was found, that the axis (A) of the central support of the elevator was loose. (see fig. 1). This axis is supported in a bushing. Through a hole (B) in this bushing, the axis is fastened by a weld. This welded connection did not exist any more.*

Das Höhenruder demontieren. Prüfen, ob die Lagerachse (A) fest sitzt. Dabei sind zusätzlich auch die Bleche des Lagerbocks rund um die Schweißnähte (C) auf Risse zu prüfen (mindestens mit einer Lupe 10facher Vergrößerung). Gegebenenfalls ist der Lagerbock zu ersetzen. Diese TM ist als Anhang in das Flug- und Betriebshandbuch einzufügen und im Berichtsstatus einzutragen.

*At that occasion, the sheet metal of the support is to be checked for cracks around the welds (C) (at least with a 10x magnification loupe).*

*When indicated, the support must be replaced.*
